Research Results

Field Operations for GPS-assisted
Winter Maintenance Vehicles
(Avalanche Sensing)

Managing Avalanches Along Roadways

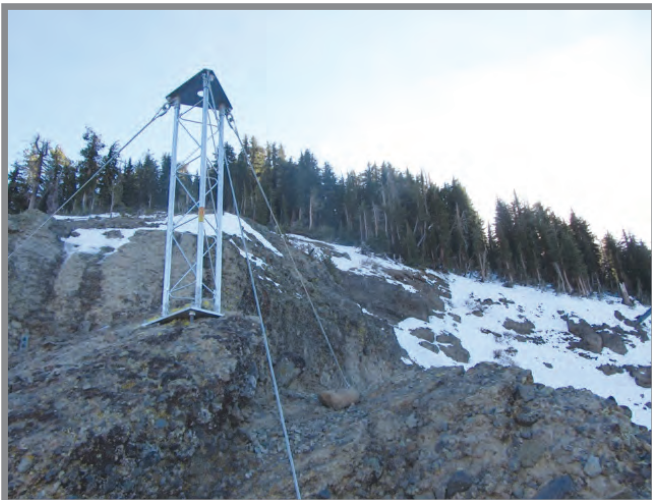
Tower installed on Carson Spur to hold the instrumentation equipment

The project involved several steps. To determine the best location to place the prototype, Caltrans Surveys measured the entire face of the Carson Spur using a stationary laser scanner. The researchers then installed a 5-foot tower to hold the instrumentation equipment on the rock face. The system included an outdoor network video camera to allow remote monitoring and visual corroboration of the sensor measurements. The wind speed sensor can detect wind speeds up to 224 mph, with an accuracy of 2.2 mph. The temperature sensor can detect temperatures down to -58°F, with an accuracy of 0.54°F. The equipment was powered by a wind generator that can supply up to 350 watts.

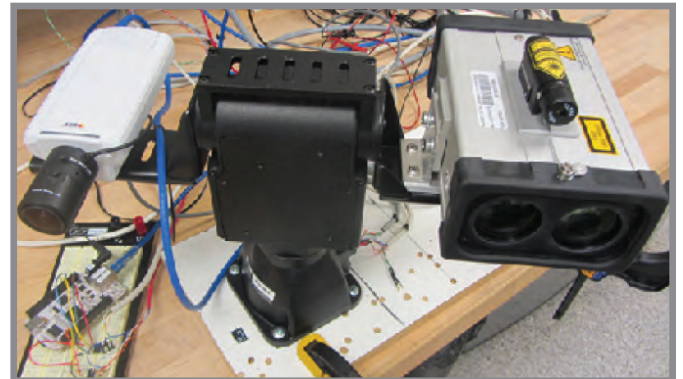
Prototype system in lab

Caltrans, in partnership with the University of California, Davis Advanced Highway Maintenance and Construction Technology Research Center, designed a prototype avalanche sensing and detection system using commercially available parts. The system was placed in the avalanche zone on State Route 88, known as chute 4 of the Carson Spur.

The instruments were successfully bench-tested, but installing the equipment was more challenging than anticipated. In particular, it was difficult to find a location for the tower that provided the right field of view for imaging and distance measurements as well as secure mounting and system survivability. For this reason, the system was not installed by the end of the project. Final system installation, field testing, and analysis are occurring in follow-up research.
